PHOTOGRAPHIC SURVEY OF THE LDEF MISSION

National Aeronautics and
Space Administration

NASA Special Publication 531
1996

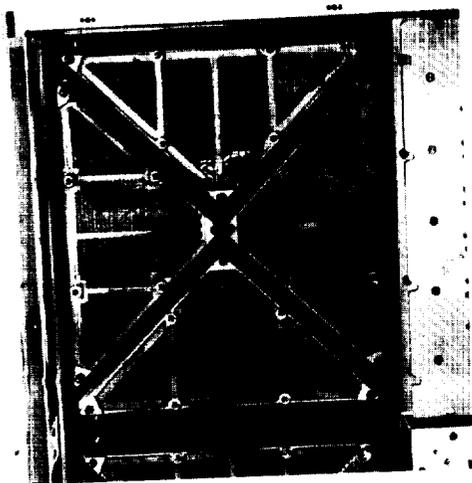
Figure 233
Photo No.: KSC-390C-1558.03
Dup. Neg. No.: L91-9091
LISAR No.: EL-1994-00339
Photo Credit: KSC
Photo Date: 3/5/90
Location: KSC SAEF II
Subject: Postflight Detail of Upper Left of Tray C3

Figure 233 (Postflight). This photograph is of the upper left one-sixth of the tray. The hardware of experiment AO023 appears intact, but some discoloration on the mounting hardware surfaces is apparent. Considerable staining is visible along the bond line between the support mesh and die-cast frame where the adhesive may not have been completely cleaned during pre-launch preparations. Reflections in the foil surfaces are visible.

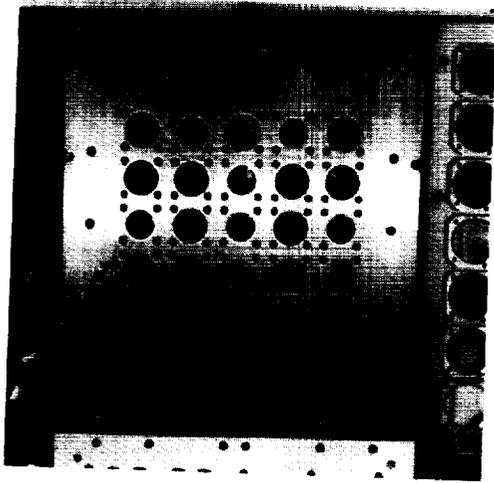
Figure 234
Photo No.: KSC-390C-1558.04
Dup. Neg. No.: L91-9092
LISAR No.: EL-1994-00340
Photo Credit: KSC
Photo Date: 3/5/90
Location: KSC SAEF II
Subject: Postflight Detail of Upper Center of
Tray C3

Figure 234 (Postflight). This photograph is of the upper center one-sixth of the tray. Experiment AO034 has some uniform brown discoloration on the cover plate surface. Reflections from photographic lights are visible on the sensor surfaces.

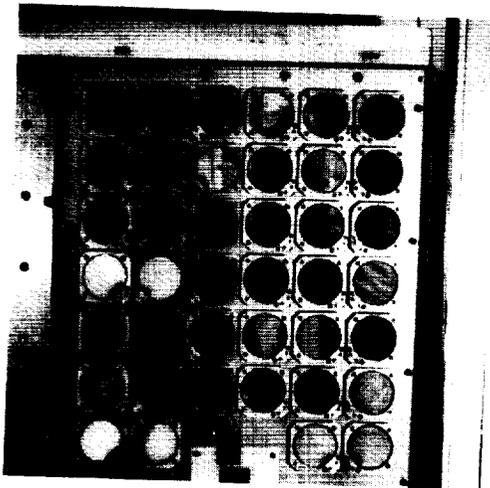
Figure 235
Photo No.: KSC-390C-1558.05
Dup. Neg. No.: L91-9093
LISAR No.: EL-1994-00351
Photo Credit: KSC
Photo Date: 3/5/90
Location: KSC SAEF II
Subject: Postflight Detail of Upper Right of Tray C3

Figure 235 (Postflight). This photograph is of the upper right one-sixth of the tray. The sensors of experiment AO201 are intact. There is a brown discoloration on the detector frames and baseplate. A reflection of the room surroundings is visible in the sensor surfaces.

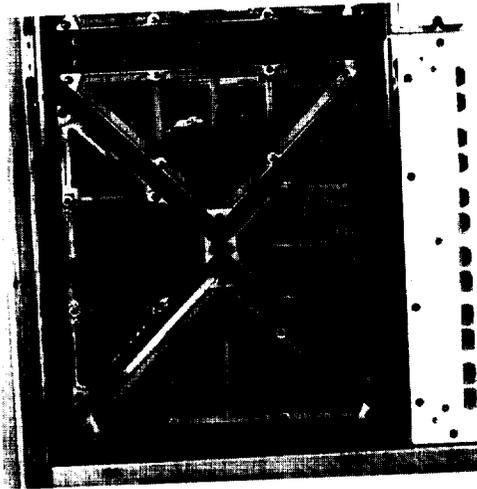
Figure 236
Photo No.: KSC-390C-1558.06
Dup. Neg. No.: L91-9094
LISAR No.: EL-1994-00352
Photo Credit: KSC
Photo Date: 3/5/90
Location: KSC SAEF II
Subject: Postflight Detail of Lower Left of Tray C3

Figure 236 (Postflight). This photograph is of the lower left one-sixth of the tray. The hardware of experiment AO023 is intact, but some discoloration on the mounting hardware surfaces is apparent. Considerable staining is visible along the bond line between the support mesh and the die-cast frame where the adhesive may not have been completely cleaned during prelaunch preparations. Reflections in the foil surfaces are visible.

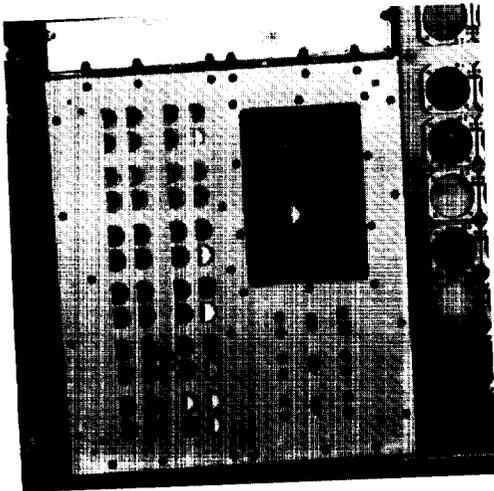
Figure 237
Photo No.: KSC-390C-1558.07
Dup. Neg. No.: L91-9095
LISAR No.: EL-1994-00364
Photo Credit: KSC
Photo Date: 3/5/90
Location: KSC SAEF II
Subject: Postflight Detail of Lower Center of
Tray C3

Figure 237 (Postflight). This photograph is of the lower center one-sixth of the tray. The sensors of experiment AO114 seem to be intact. The paint that was originally white on the faceplate is now a uniform light tan. The polished aluminum face plate insert in the upper right quadrant has become darker.

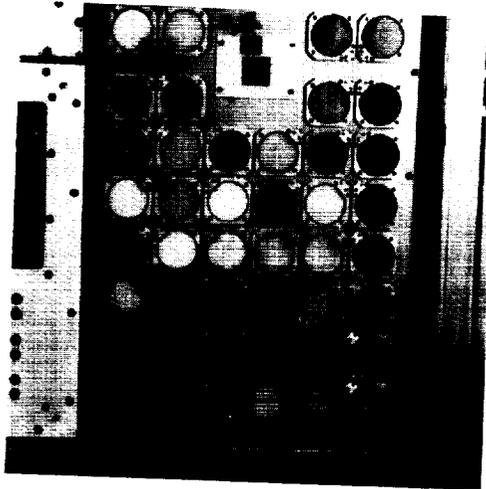
Figure 238
Photo No.: KSC-390C-1558.08
Dup. Neg. No.: L91-9096
LISAR No.: EL-1994-00365
Photo Credit: KSC
Photo Date: 3/5/90
Location: KSC SAEF II
Subject: Postflight Detail of Lower Right of Tray C3

Figure 238 (Postflight). This photograph is of the lower right one-sixth of the tray. The sensors of experiment AO201 are intact. There is a brown discoloration on the detector frames and baseplate. A reflection of the nearby surroundings is visible in the sensor surfaces.

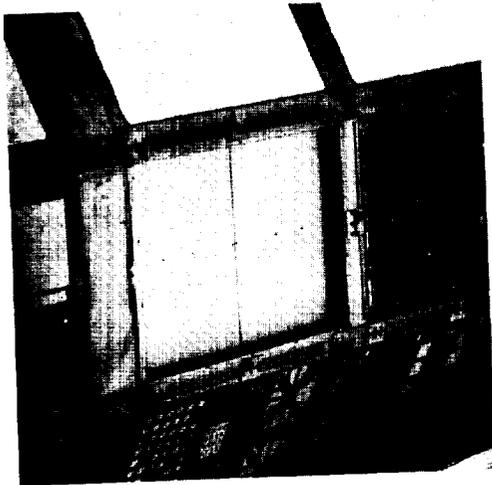
Figure 239 (In Flight). The greenish-gray tint on the debris panels is a by-product of the chromic anodize coating process. The dark green smudge along the top right edge of the left debris panel is the result of improper cleaning after prelaunch handling. The dark band across the bottom of the panels is caused by a shadow from the tray sidewall.

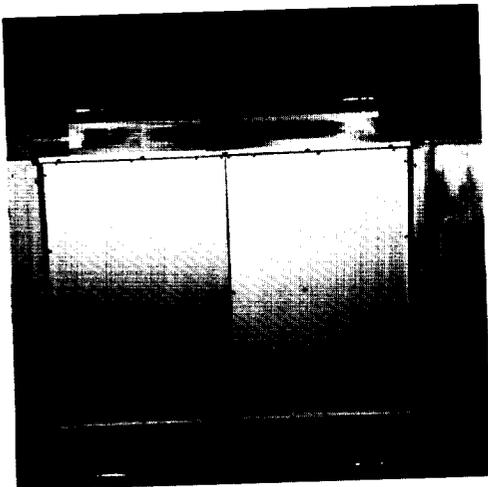
Figure 243 (Postflight). The pink and greenish-gray tints on the two debris panels are by-products of the chromic anodize coating process and are not attributed to contamination or exposure to the space environment. The two white spots in the lower left quadrant of the left debris panel appear to be debris impact craters. The light band along the right side and across the bottom of the panels is caused by light reflecting from the tray sidewalls.

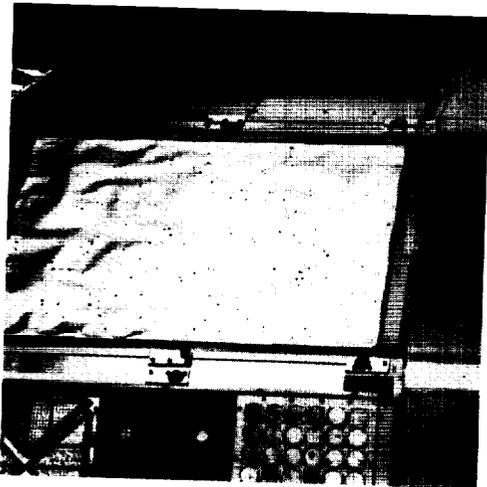
Figure 244
Photo No.: S32-76-008
Dup. Neg. No.: L90-10376
LISAR No.: EL-1994-00661
Photo Credit: JSC
Photo Date: 1/12/90
Location: In Flight
Subject: In-Flight Survey of Tray C8

Figure 244 (In Flight). The ground strap located in the center of the lower flange is intact but with a much darker copper color than in the prelaunch photograph. The thermal cover surface appears to have changed from specular to opaque (glossy white) and to be marked with many black dots of various sizes that appear to be impacts or penetrations. Many discolorations have a black center encircled by a brown halo. The cover appears to be more taut than in the prelaunch photograph and the locations of Velcro attachment pads appear as oblong indentations in the thermal cover.

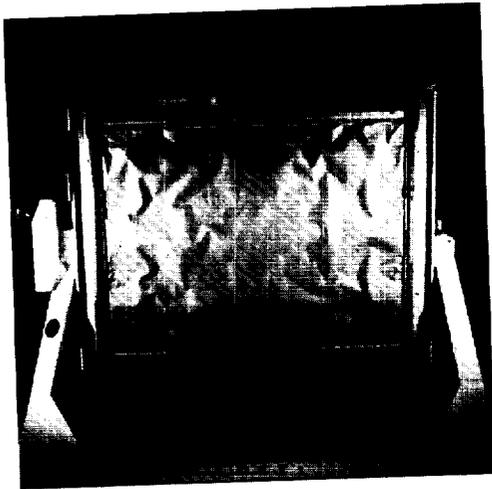
Figure 245
Photo No.: KSC-390C-1543.09
Dup. Neg. No.: L91-8886
LISAR No.: EL-1994-00212
Photo Credit: KSC
Photo Date: 3/2/90
Location: KSC SAEF II
Subject: Postflight Survey of Tray C8

Figure 245 (Postflight). The thermal cover surface appears to have changed from specular to opaque (glossy white) with many black dots of various sizes that appear to be impact or penetration discolorations. Many of the discolorations appear to have a black center encircled by a brown halo and then by a white halo. Other white circular discolorations also appear on the cover surface. The darker discolorations are probably the result of craters penetrating the 5-mil Teflon film, thus allowing atomic oxygen to oxidize or erode the layer of vapor-deposited silver beneath. An item of interest is the impact crater in the lower right corner of the cover that has a spray pattern originating from the point of impact. The cover is not as taut as in the in-flight photograph and the locations of Velcro attachment pads are not as prominent. The ground strap is in place with no visible damage; however, it is a deeper copper color.

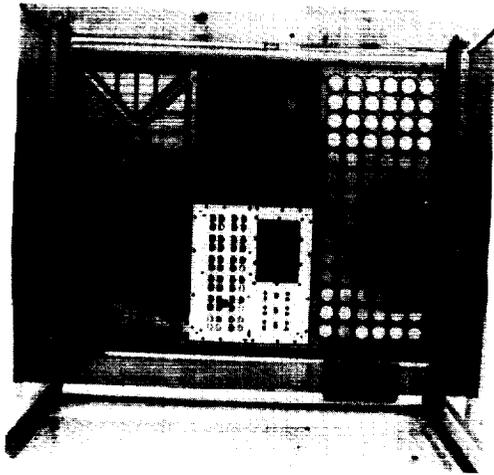
Figure 253
Photo No.: KSC-384C-14.03
Dup. Neg.: L84-7005
LISAR No.: EL-1994-00330
Photo Credit: KSC
Photo Date: 1/9/84
Location: KSC SAEF II
Subject: Preflight Survey of Tray C9

Figure 253 (Preflight). The prelaunch photograph shows the location of four experiments integrated into a 3-in-deep tray. Experiment AO023 is located in the left one-third, experiment AO034 in the upper center, experiment AO114 in the lower center, and experiment AO201 in the right one-third of the tray. Experiment AO201 is described in figure 211 and the other experiments are described in figure 230.

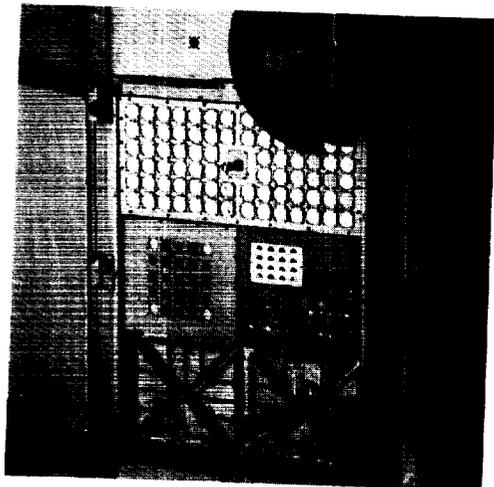
Figure 254
Photo No.: S32-78-100
Dup. Neg. No.: L90-10451
LISAR No.: EL-1994-00022
Photo Credit: JSC
Photo Date: 1/12/90
Location: In Flight
Subject: In-Flight Survey of Tray C9

Figure 254 (In Flight). The tray appears to be unchanged from the preflight condition except for a little discoloration around some fasteners and on the mounting plates. Reflections of the surroundings appear to exist on some sensor surfaces. All experiment hardware appears intact. The color of the center coverplates was influenced by lighting conditions.

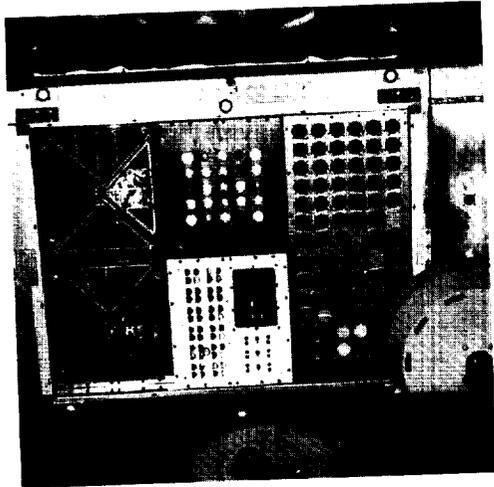
Figure 255
Photo No.: KSC-390C-1030.09
Dup. Neg. No.: L90-13407
LISAR No.: EL-1994-00143
Photo Credit: KSC
Photo Date: 2/9/90
Location: KSC SAEF II
Subject: Postflight Survey of Tray C9

Figure 255 (Postflight). The tray corner clamp blocks are unanodized aluminum, which accounts for the difference in color between the corner clamp blocks and the center clamp blocks. All experiments are intact. Reflections of the surroundings are visible in the sensor surfaces.

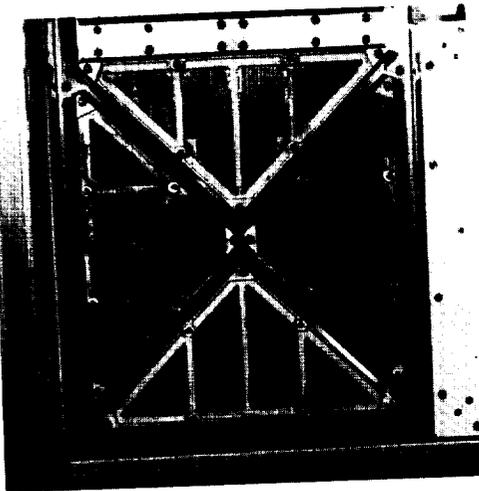
Figure 256
Photo No.: KSC-390C-1538.02
Dup. Neg. No.: L91-8840
LISAR No.: EL-1994-00692
Photo Credit: KSC
Photo Date: 3/2/90
Location: KSC SAEF II
Subject: Postflight Detail of Lower Left of Tray C9

Figure 256 (Postflight). This photograph is of the lower left one-sixth of the tray. The mesh support, the detector foils, and the bond joints show no sign of physical failure. There are some darker contamination stains in areas on the die-cast aluminum frames where adhesive residue remained after preflight cleaning.

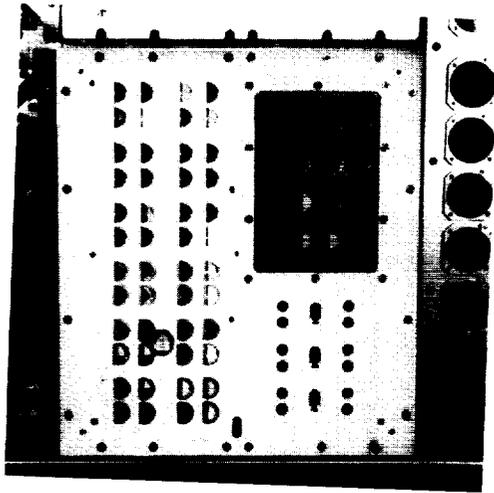
Figure 257
Photo No.: KSC-390C-1538.03
Dup. Neg. No.: L91-8841
LISAR No.: EL-1994-00693
Photo Credit: KSC
Photo Date: 3/2/90
Location: KSC SAEF II
Subject: Postflight Detail of Lower Part of Tray C9

Figure 257 (Postflight). This photograph is of the lower one-sixth of the tray. Experiment AO114 shows a little change in the color of the white paint. A very faint tan tint exists around the outside edges of the cover plate and the outside ring of fasteners. The material specimens remain intact in their mountings and seem to have survived well the exposure to the space environment. The polished aluminum cover plate has darkened and seems to have a duller finish than in the preflight photograph.

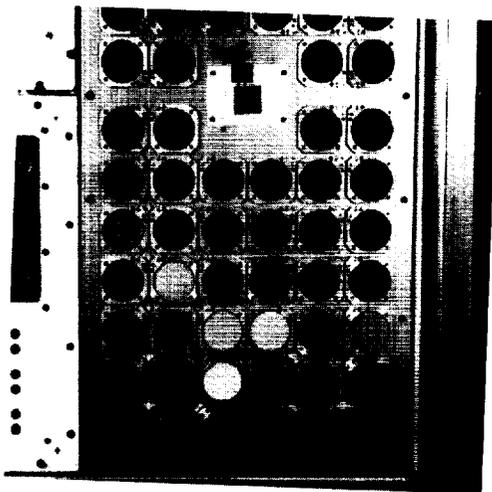
Figure 258
Photo No.: KSC-390C-1538.04
Dup. Neg. No.: L91-8842
LISAR No.: EL-1994-00694
Photo Credit: KSC
Photo Date: 3/2/90
Location: KSC SAEF II
Subject: Postflight Detail of Lower Right of Tray C9

Figure 258 (Postflight). This photograph is of the lower right one-sixth of the tray. Close inspection of the photograph reveals several locations where impacts on detector surfaces are visible. A faint gold or tan stain is visible around several fasteners and in a rectangular configuration near the center along the bottom edge of the detector mounting plate. Stains are also visible near the top right edge of the solar sensor, on the mounting plate, and around the extreme edges of the solar sensor baseplate. The colors and designs on the detectors are reflections of the surrounding area.

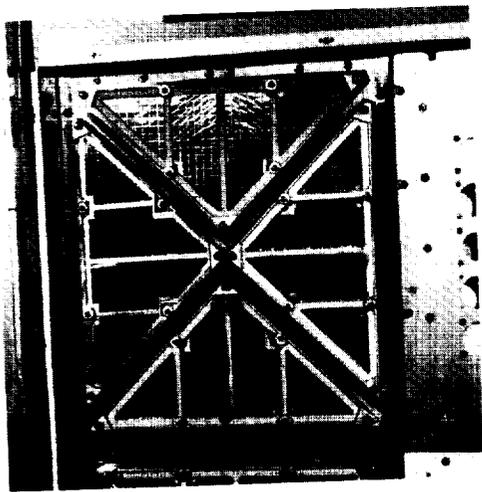
Figure 259
Photo No.: KSC-390C-1538.10
Dup. Neg. No.: L91-8848
LISAR No.: EL-1994-00648
Photo Credit: KSC
Photo Date: 3/2/90
Location: KSC SAEF II
Subject: Postflight Detail of Upper Left of Tray C9

Figure 259 (Postflight). This photograph is of the upper left one-sixth of the tray. The sensor foils are intact, but some areas of the mounting frames appear discolored.

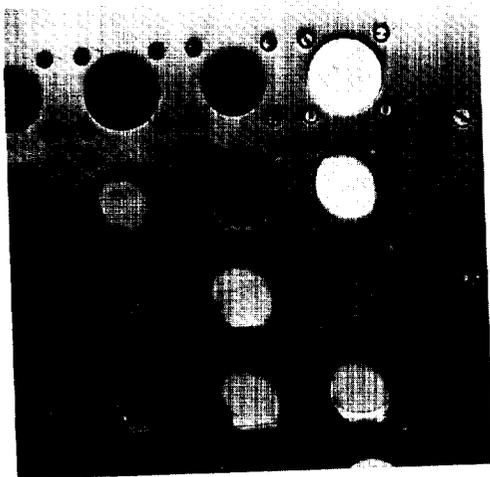
Figure 260
Photo No.: KSC-390C-1540.08
Dup. Neg. No.: L91-8858
LISAR No.: EL-1994-00152
Photo Credit: KSC
Photo Date: 3/2/90
Location: KSC SAEF II
Subject: Postflight Detail of Upper Center of
Tray C9

Figure 260 (Postflight). This close-up is of a portion of the upper center one-sixth of the tray. The test specimens appear intact. Some shadows appear on some of the recessed test specimens.

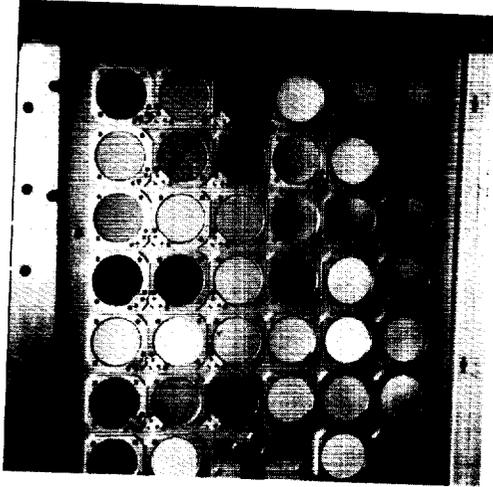
Figure 261
Photo No.: KSC-390C-1542.02
Dup. Neg. No.: L91-10128
LISAR No.: EL-1994-00153
Photo Credit: KSC
Photo Date: 3/2/90
Location: KSC SAEF II
Subject: Postflight Detail of Upper Right of Tray C9

Figure 261 (Postflight). This close-up is of the upper right one-sixth of the tray. The impact sensors are intact. The different colors are reflections of the surrounding area. Evidence of space debris impacts are visible on some of the lighter colored sensors. Some light discoloration is visible around the baseplate fasteners.

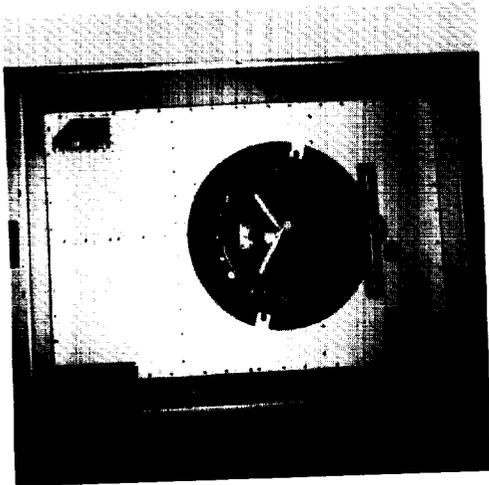
Figure 262 (Preflight). The tray assembly consisted of a modified 6-in-deep peripheral experiment tray, a chromic-anodized aluminum mounting plate with chamfered corners, an initiate switch assembly, an initiate system status indicator assembly, nonmagnetic stainless steel fasteners, and a modified mechanical grapple fixture that was provided by JSC with a camera target attached. The camera target, which was black with white markings, was attached to the right edge of the grapple fixture and assisted the operator in positioning the RMS end effector. The opening in the upper left corner of the mounting plate provided access to the initiate system activation connectors and was covered by an aluminum plate prior to installing the LDEF in the cargo bay of the orbiter. The black square in the right center of the mounting plate adjacent to the camera target, is the initiate system status indicator assembly. Scratch marks from preassembly activities are visible on the lower right corner and on the upper left corner slightly below the access opening of the grapple fixture mounting plate.

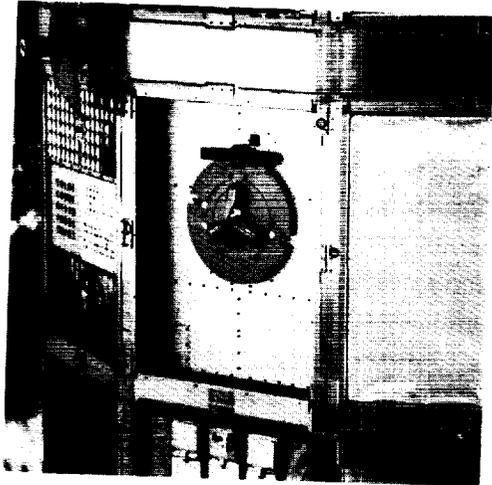
Figure 263
Photo No.: S32-78-073
Dup. Neg. No.: L90-10443
LISAR No.: EL-1994-00016
Photo Credit: JSC
Photo Date: 1/12/90
Location: In Flight
Subject: In-Flight Survey of Tray C10

Figure 263 (In Flight). The grapple tray assembly appears to be without physical damage. The color of the tray and surrounding areas of the LDEF have a somewhat unrealistic pink or orange cast. The dark gray circular discolorations on the outer section of the grapple fixture appear to be the locations of impact craters where the surrounding surface coating has been disturbed.

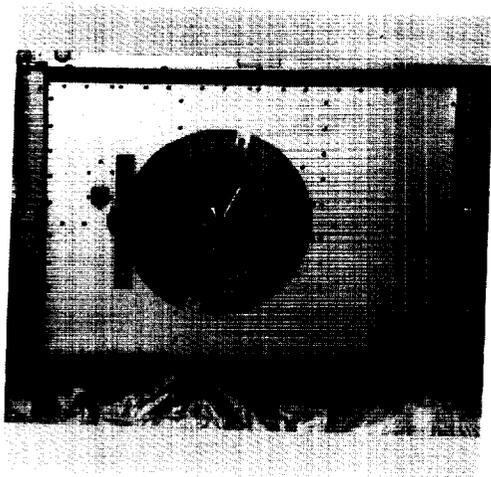
Figure 264
Photo No.: KSC-390C-612.03
Dup. Neg. No.: L92-17794
LISAR No.: EL-1994-00161
Photo Credit: KSC
Photo Date: 1/30/90
Location: KSC OPF
Subject: Postflight Survey of Tray C10

Figure 264 (Postflight). The grapple tray assembly is without physical damage. The chromic anodized aluminum mounting plate is in prelaunch condition with only a very light tan discoloration. The aluminum cover plate located in the lower right corner of the tray has a number of irregular darker discolorations around the outer edges that appear to be fingerprints. The dark gray circular discolorations on the outer section of the grapple fixture are impact craters where the surrounding surface coating has been disturbed.

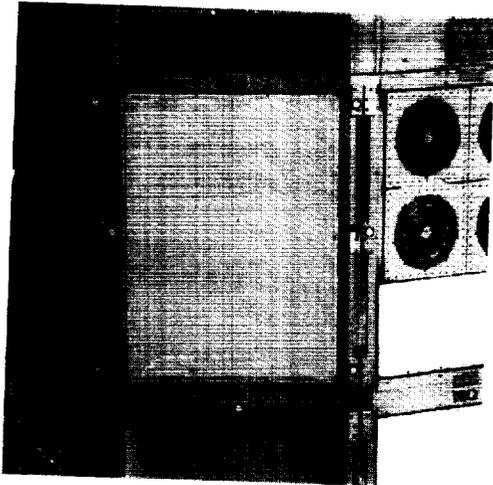
Figure 266
Photo No.: S32-78-042
Dup. Neg. No.: L90-10434
LISAR No.: EL-1994-00010
Photo Credit: JSC
Photo Date: 1/12/90
Location: In Flight
Subject: In-Flight Survey of Tray C11

Figure 266 (In Flight). The thermal cover surface appears to have changed from specular to opaque. There are indications of a number of impacts on or penetrations of the thermal cover. The cover is more taut than in the prelaunch photograph and the locations of Velcro attachment pads are apparent. The ground strap is in place with no visible damage, but it is a darker color.

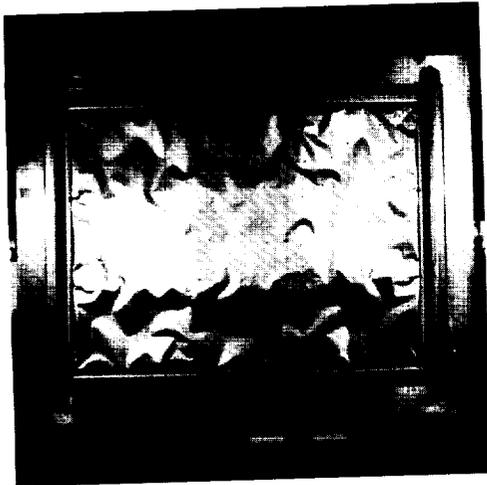
Figure 267
Photo No.: KSC-390C-2109.09
Dup. Neg. No.: L91-9372
LISAR No.: EL-1994-00299
Photo Credit: KSC
Photo Date: 3/20/90
Location: KSC SAEF II
Subject: Postflight Survey of Tray C11

Figure 267 (Postflight). The thermal cover surface appears to have changed from specular to opaque with many black dots of various sizes that indicate impacts on or penetrations of the thermal cover. Photographic light reflections wash out many of the details. The cover is not as taut as in the in-flight photograph and locations of Velcro attachment pads are not as prominent. The ground strap is in place with no visible damage, but it is a deeper copper color.

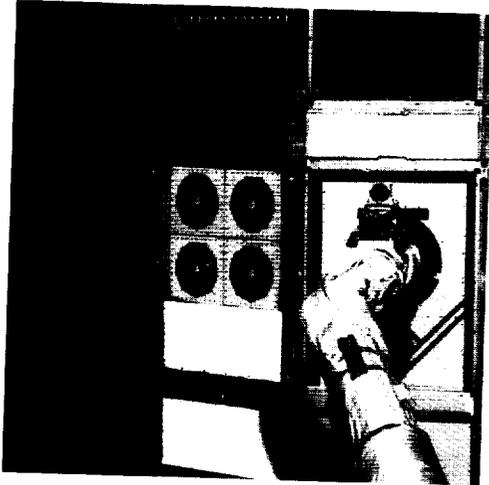
Figure 276
Photo No.: S32-89-048
Dup. Neg. No.: L90-10501
LISAR No.: EL-1994-00135
Photo Credit: JSC
Photo Date: 1/12/90
Location: In Flight
Subject: In-Flight Survey of Tray C12

Figure 276 (In Flight). The experiment appears to be without physical damage. The colors of two of the four exposed coils of the fiber optic cables have changed significantly. The cable located in the upper right corner, originally a bright orange, appears to be dark brown and the cable in the lower left has changed from a light blue to a blue gray. Two brown circular discolorations have appeared. One discoloration is on the lower edge of the mounting plate in the upper left and one is on the upper edge of the mounting plate in the lower right. Dark brown irregular-shaped discolorations are visible along the lower edge and on each of the vertical edges of the cover plate.

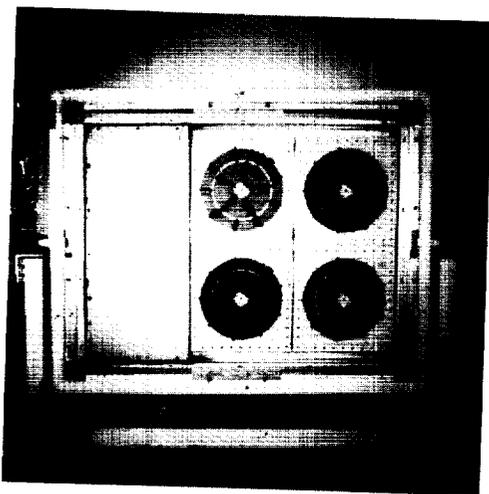
Figure 277
Photo No.: KSC-390C-2204.02
Dup. Neg. No.: L91-9317
LISAR No.: EL-1994-00300
Photo Credit: KSC
Photo Date: 3/22/90
Location: KSC SAEF II
Subject: Postflight Survey of Tray C12

Figure 277 (Postflight). The colors of two coils of the externally mounted fiber optic cables have changed significantly from preflight. Four dark brown areas of discoloration are visible around the openings to the tray interior; these openings are located between the mounting plates. Dark brown irregular discolorations are also visible along the vertical and upper edges of the cover plate. An irregular vertical stain (not observed in the in-flight photograph) on the upper right corner of the cover plate is now visible.

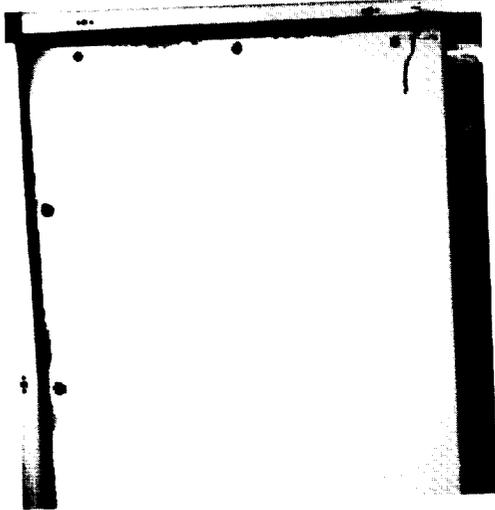
Figure 278
Photo No.: KSC-390C-2204.03
Dup. Neg. No.: L91-9318
LISAR No.: EL-1994-00616
Photo Credit: KSC
Photo Date: 3/22/90
Location: KSC SAEF II
Subject: Postflight Detail of Upper Left of Tray C12

Figure 278 (Postflight). This photograph is of the upper left one-sixth of the tray. The cover without cable has extensive brown contamination along the left and upper edges and around the fasteners. There is a postretrieval liquid run on the upper right corner area of the cover. The existence of a liquid after almost 6 years in space was a surprise. There is also a flow pattern extending from the top edge near the left corner.

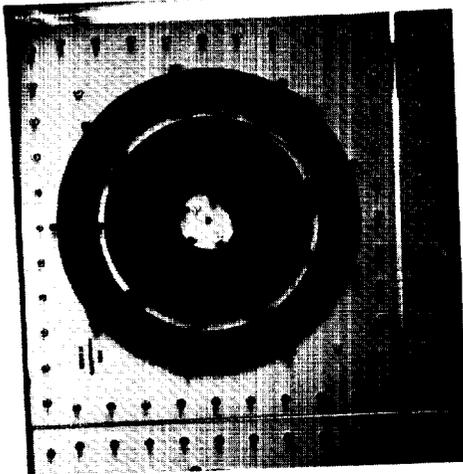
Figure 279
Photo No.: KSC-390C-2204.04
Dup. Neg. No.: L91-9319
LISAR No.: EL-1994-00526
Photo Credit: KSC
Photo Date: 3/22/90
Location: KSC SAEF II
Subject: Postflight Detail of Upper Center of
Tray C12

Figure 279 (Postflight). This photograph is of the upper center one-sixth of the tray. The cable has changed from a light blue to a blue gray. The color of the silicone-rubber spacers under the coil attachment clips have changed from clear to brown and have discolored the fiber coils in areas adjacent to the spacers. A flow pattern of discoloration appears to extend downward from fasteners used to secure the four mounting plates.

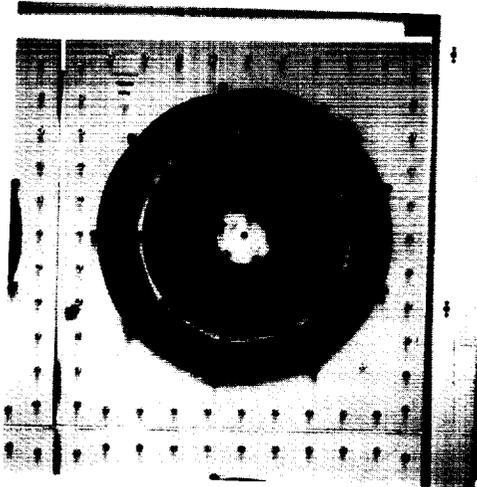
Figure 280
Photo No.: KSC-390C-2204.05
Dup. Neg. No.: L91-9320
LISAR No.: EL-1994-00527
Photo Credit: KSC
Photo Date: 3/22/90
Location: KSC SAEF II
Subject: Postflight Detail of Upper Right of
Tray C12

Figure 280 (Postflight). This photograph is of the upper right one-sixth of the tray. The silicone-rubber spacers under the coil attachment clips have changed from clear to brown and have discolored the fiber coils in areas adjacent to the spacers.

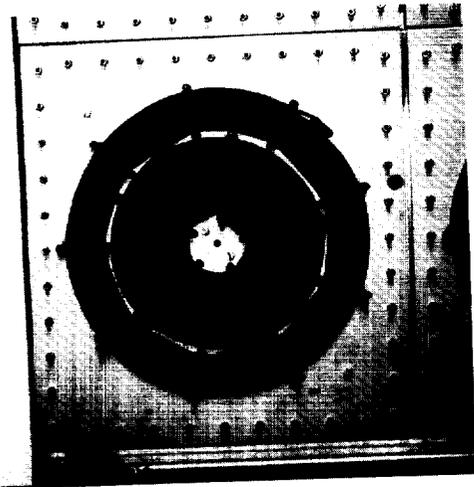
Figure 282
Photo No.: KSC-390C-2204.07
Dup. Neg. No.: L91-9322
LISAR No.: EL-1994-00528
Photo Credit: KSC
Photo Date: 3/22/90
Location: KSC SAEF II
Subject: Postflight Detail of Lower Center of
Tray C12

Figure 282 (Postflight). This photograph is of the lower center one-sixth of the tray. The silicone-rubber spacers under the coil attachment clips have changed from clear to brown and have discolored the fiber coils in areas adjacent to the spacers. A flow pattern of discoloration appears to extend downward from fasteners used to secure the four mounting plates.

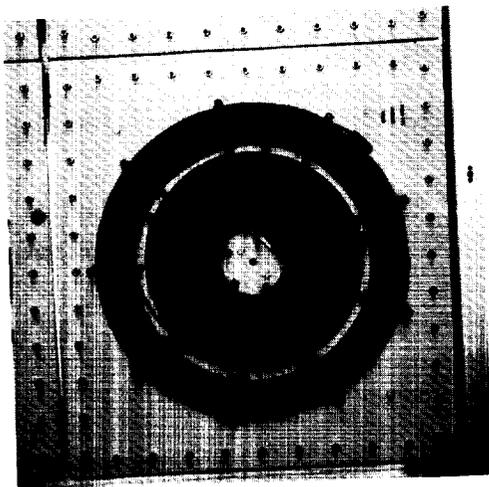
Figure 283
Photo No.: KSC-390C-2204.08
Dup. Neg. No.: L91-9323
LISAR No.: EL-1994-00506
Photo Credit: KSC
Photo Date: 3/22/90
Location: KSC SAEF II
Subject: Postflight Detail of Lower Right of
Tray C12

Figure 283 (Postflight). This photograph is of the lower right one-sixth of the tray. The cable, originally a bright orange, is dark brown. The silicone-rubber spacers under the coil attachment clips have changed from clear to brown and have discolored the fiber coils in areas adjacent to the spacers. A flow pattern of discoloration appears to extend downward from fasteners used to secure the four mounting plates.

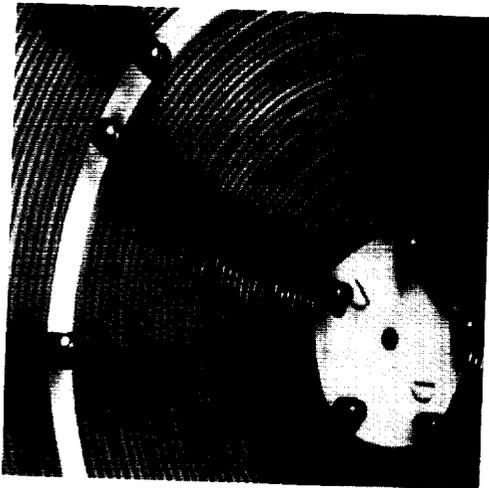
Figure 285
Photo No.: KSC-390C-2205.09
Dup. Neg. No.: L91-9336
LISAR No.: EL-1994-00508
Photo Credit: KSC
Photo Date: 3/22/90
Location: KSC SAEF II
Subject: Postflight Detail of Upper Center Coil of
Tray C12

Figure 285 (Postflight). This close-up photograph is of the upper center coil, which shows the silicone-rubber spacers under the coil attachment clips. The spacers have changed from clear to brown and have discolored the fiber coils in areas adjacent spacers.

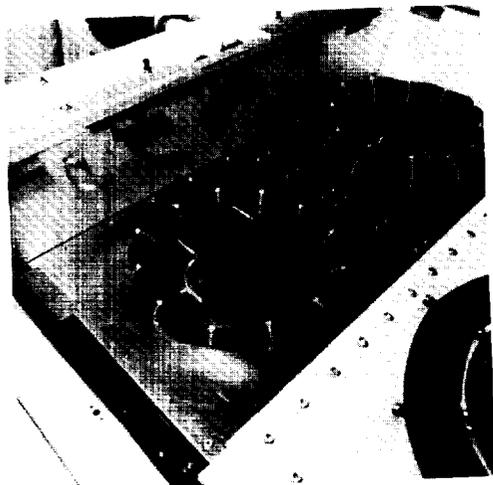
Figure 286
Photo No.: KSC-390C-2210.10
Dup. Neg. No.: L91-9313
LISAR No.: EL-1994-00535
Photo Credit: KSC
Photo Date: 3/22/90
Location: KSC SAEF II
Subject: Postflight Detail of Tray C12

Figure 286 (Postflight). This photograph is of the area beneath the cover without cable. The far side wall and the bottom of the tray appeared wet with brown contamination along the cover edges.

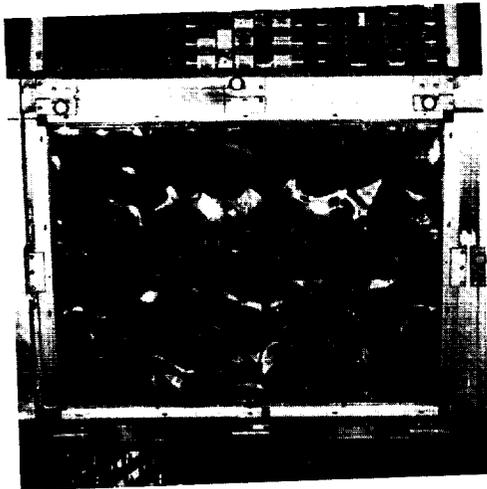
Figure 288
Photo No: KSC-390C-1066.09
Dup. Neg. No.: L90-13478
LISAR No.: EL-1994-00188
Photo Credit: KSC
Photo Date: 2/8/90
Location: KSC SAEF II
Subject: Postflight Survey of Tray D1

Figure 288 (Postflight). The thermal cover appears specular and no change from in-flight condition is indicated. The bright irregular discoloration located above the grounding strap at about one-third of the height of the thermal cover from the bottom edge did not appear in the in-flight photograph. The discoloration appears to be a piece of material from a degraded experiment that has become attached to the cover. The cover has numerous white dots that may also be debris from other degraded experiments. The cover is less taut than in the in-flight photograph, but the locations of the Velcro attachment pads are still evident.

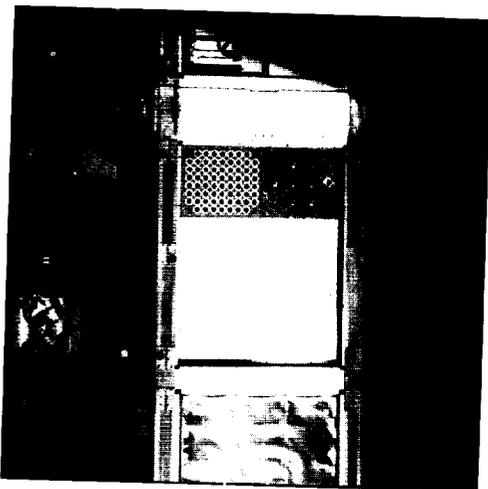
Figure 296
Photo No.: S32-89-013
Dup. Neg. No.: L90-10495
LISAR No.: EL-1994-00130
Photo Credit: JSC
Photo Date: 1/12/90
Location: In Flight
Subject: In-Flight Survey of Tray D2

Figure 296 (In Flight). The aluminum mounting plate of experiment AO172, which was painted with Chemglaze II A-276 white paint, is now a uniform brown as are the diagonal stripes on experiment AO189. Light reflections appear on the unpainted stripes of experiment AO189. Reflected light obscures any color definition of the panels of experiment S0001.

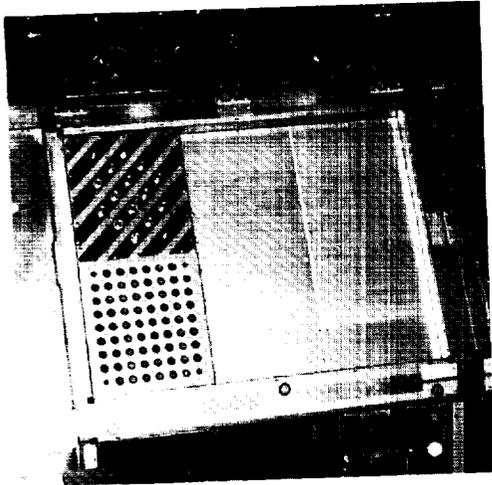
Figure 297
Photo No.: KSC-390C-731.11
Dup. Neg. No.: L92-17662
LISAR No.: EL-1994-00165
Photo Credit: KSC
Photo Date: 2/1/90
Location: KSC O & C building
Subject: Postflight Survey of Tray D2

Figure 297 (Postflight). The surfaces of experiments AO172 and AO189 that were painted with Chemglaze II A-276 white paint are now a uniformly discolored tan. The faint patterns in experiment S0001 panels were observed in preflight.

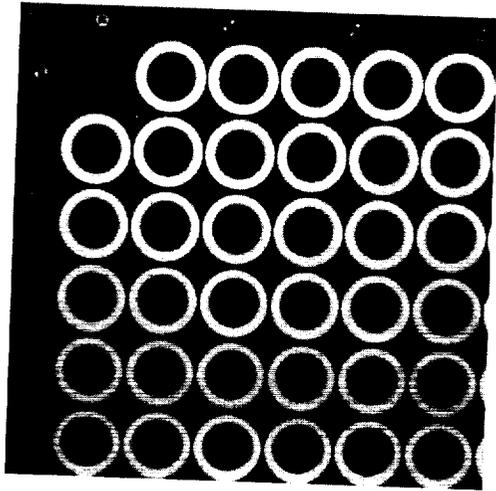
Figure 299
Photo No.: KSC-390C-2038.11
Dup. Neg. No.: L91-9270
LISAR No.: EL-1994-00463
Photo Credit: KSC
Photo Date: 3/16/90
Location: KSC SAEF II
Subject: Postflight Detail of Lower Left of Tray D

Figure 299 (Postflight). This photograph is of the lower left one-sixth of the tray. The sensors appear undamaged, but the white paint on the baseplate is now tan.

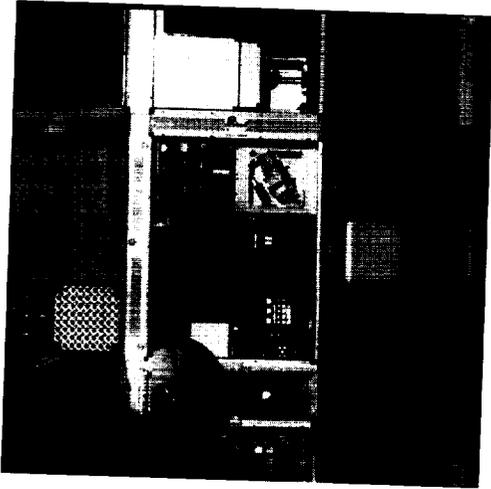
Figure 301
Photo No.: S32-89-008
Dup. Neg. No.: L90-10494
LISAR No.: EL-1994-00129
Photo Credit: JSC
Photo Date: 1/12/90
Location: In Flight
Subject: In-Flight Survey of Tray D3

Figure 301 (In Flight). Experiment M0003 appears to be in good condition except that approximately half of the thin-film polymers in the lower right tray section are loose at one end. Other material samples seem intact, but they appear discolored. Experiment M0002-1 appears to be without physical damage, but it has a light tan discoloration on the detector housings and the surfaces of the experiment support structure.

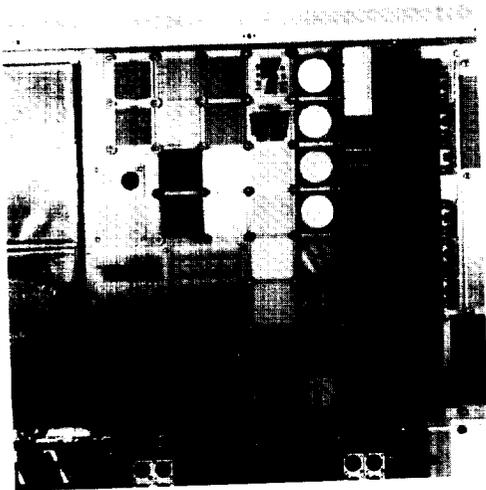
Figure 304
Photo No.: KSC-390C-1485.07
Dup. Neg. No.: L91-9254
LISAR No.: EL-1994-00065
Photo Credit: KSC
Photo Date: 2/28/90
Location: KSC SAEF II
Subject: Postflight Detail of Upper Center of Tray D3

Figure 304 (Postflight). This photograph is of the upper center one-sixth of the tray. Most test specimens appear intact, but there appears to be significant brown discoloration on specimens and specimen mounting hardware. Composite material samples located in upper right, upper center, and lower center remain intact, but they are bleached or discolored.

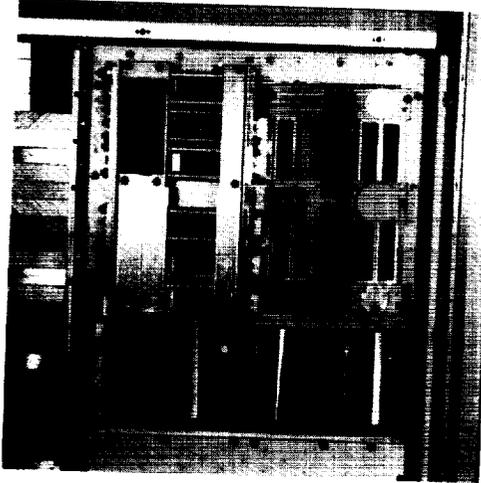
Figure 305
Photo No.: KSC-390C-1485.08
Dup. Neg. No.: L91-9255
LISAR No.: EL-1994-00066
Photo Credit: KSC
Photo Date: 2/28/90
Location: KSC SAEF II
Subject: Postflight Detail of Upper Right of Tray D3

Figure 305 (Postflight). This photograph is of the upper right one-sixth of the tray. Most test specimens appear intact, but there seems to be significant brown discoloration on specimens and specimen mounting hardware. Composite material samples located in upper right, upper center, and lower center remain intact, but they are bleached or discolored.

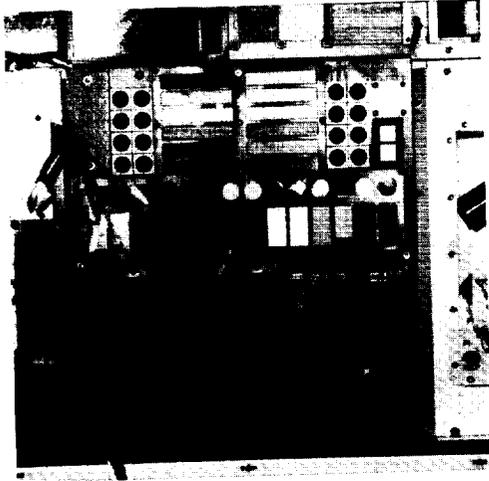
Figure 307
Photo No.: KSC-390C-1485.10
Dup. Neg. No.: L91-9257
LISAR No.: EL-1994-00093
Photo Credit: KSC
Photo Date: 2/28/90
Location: KSC SAEF II
Subject: Postflight Detail Survey of Lower Center of
Tray D3

Figure 307 (Postflight). This photograph is of the lower center one-sixth of the tray. Most test samples appear intact, but samples and mounting hardware have extensive discolorations. Composite material samples that are located in the upper right, the upper center, and the lower center remain intact, but they are bleached or discolored.

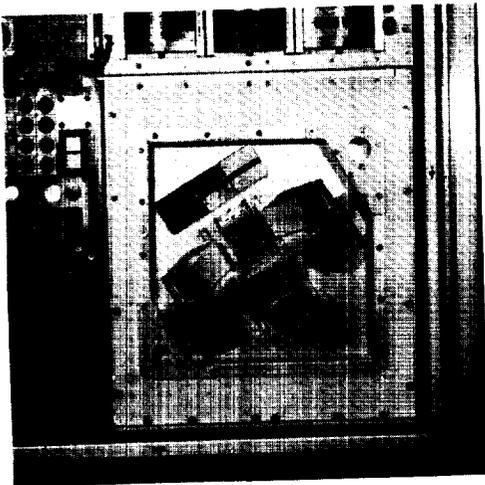
Figure 308
Photo No.: KSC-390C-1485.11
Dup. Neg. No.: L91-9258
LISAR No.: EL-1994-00094
Photo Credit: KSC
Photo Date: 2/28/90
Location: KSC SAEF II
Subject: Postflight Detail of Lower Right of
Tray D3

Figure 308 (Postflight). Experiment M0002-1 in the lower right one-sixth of the tray appears intact, but it is a somewhat uniform tan rather than white, which was the color it was painted before flight.

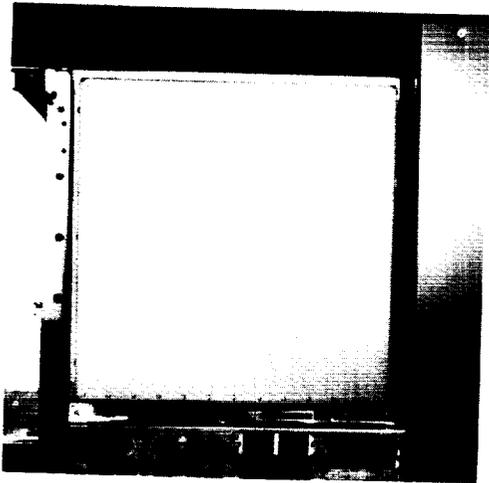
Figure 312
Photo No.: KSC-390C-1478.07
Dup. Neg. No.: L91-9177
LISAR No.: EL-1994-00034
Photo Credit: KSC
Photo Date: 2/28/90
Location: KSC SAEF II
Subject: Postflight Detail of Upper Center of
Tray D4

Figure 312 (Postflight). This photograph is of the upper center one-sixth of the tray. The signal conditioning unit thermal cover that was painted with IITRI S13G-LO white paint has become light tan or off-white.

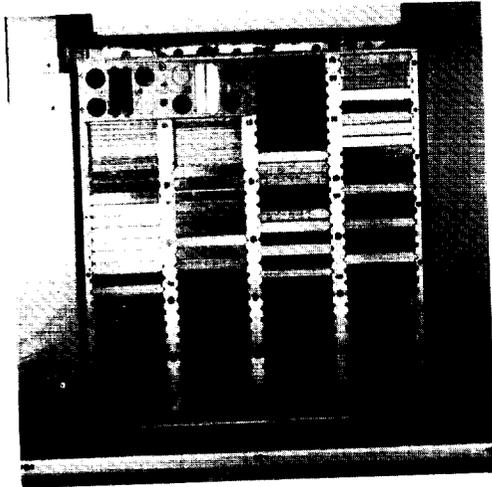
Figure 314
Photo No.: KSC-390C-1478.12
Dup. Neg. No.: L91-9182
LISAR No.: EL-1994-00036
Photo Credit: KSC
Photo Date: 2/28/90
Location: KSC SAEF II
Subject: Postflight Detail of Lower Center of
Tray D4

Figure 314 (Postflight). This photograph is of the lower center one-sixth of the tray. Many test specimens have changed color and some show signs of degradation. Some mounting hardware shows discoloration.

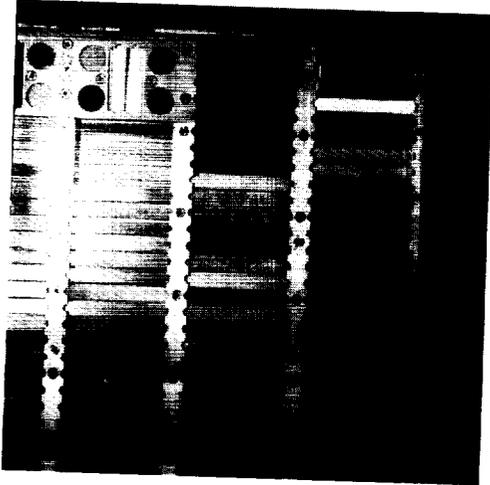
Figure 316 (Postflight). This close-up photograph is of the upper right of the lower center one-sixth of the tray. Many test specimens have changed color and some show signs of degradation. Some mounting hardware shows discoloration. The colors in the upper left area are somewhat washed out because of the lighting.

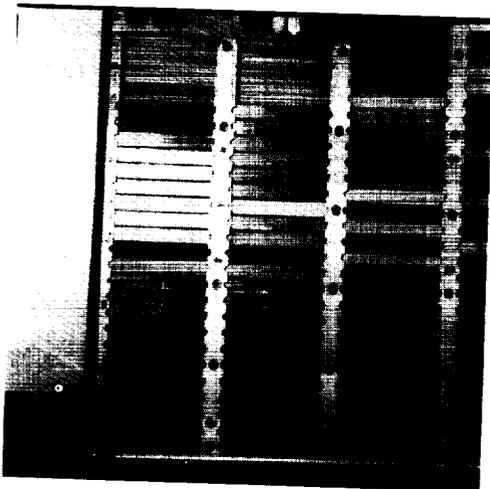
Figure 317 (Postflight). This close-up photograph is of the lower left of the lower center one-sixth of the tray. Many test specimens have changed color and some show signs of degradation. Some mounting hardware shows discoloration.

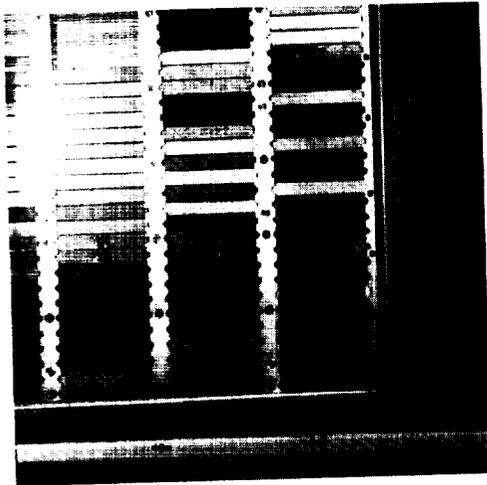
Figure 318
Photo No.: KSC-390C-1482.03
Dup. Neg. No.: L91-9156
LISAR No.: EL-1994-00050
Photo Credit: KSC
Photo Date: 2/28/90
Location: KSC SAEF II
Subject: Postflight Detail of Lower Right of Lower
Center of Tray D4

Figure 318 (Postflight). This close-up photograph is of the lower right of the lower center one-sixth of the tray. Many test specimens have changed color and some show signs of degradation. Some mounting hardware shows discoloration.

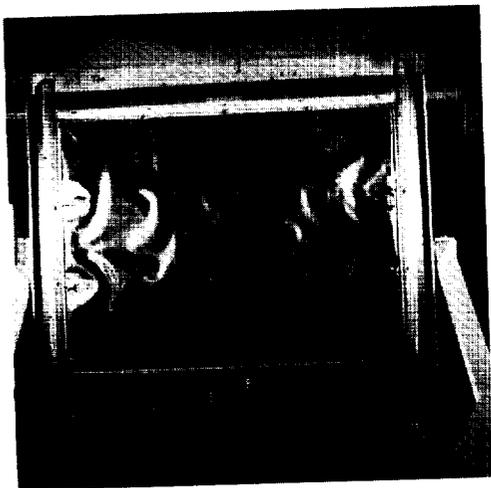
Figure 321
Photo No.: KSC-390C-2277.10
Dup. Neg. No.: L91-10204
LISAR No.: EL-1994-00311
Photo Credit: KSC
Photo Date: 3/23/90
Location: KSC SAEF II
Subject: Postflight Survey of Tray D5

Figure 321 (Postflight). The thermal cover appears specular with no apparent damage. A vertical strip of discoloration that is approximately 6-in. wide with a grainy pattern extends from top to bottom along the left side of the thermal cover. This discoloration was visible prior to flight. The cover appears less taut than in the in-flight photograph and locations of the Velcro attachment pads are not as prominent. The ground strap appears to be in place with no visible damage; however, the color appears darker than in the prelaunch photograph.

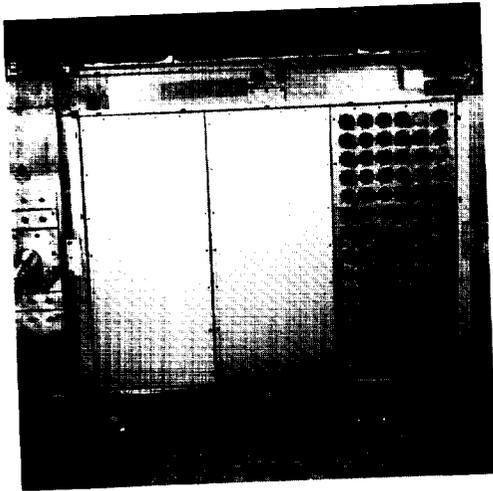
Figure 330
Photo No.: KSC-390C-1033.10
Dup. Neg. No.: L90-13440
LISAR No.: EL-1994-00180
Photo Credit: KSC
Photo Date: 2/9/90
Location: KSC SAEF II
Subject: Postflight Survey of Tray D6

Figure 330 (Postflight). The direction and the intensity of the artificial light source caused reflections that tended to wash out the brown stain on the aluminum structure. Experiment AO201 appears to be in excellent condition in the postflight photograph. All bond joints seem to have survived the space environment and the experiment hardware is intact. The blue in the metallic surface of the detectors is caused by reflections of the surrounding area. The white stripe running diagonally across the bottom two rows of detectors is the reflection of a safety control rope that restricted access to the LDEF.

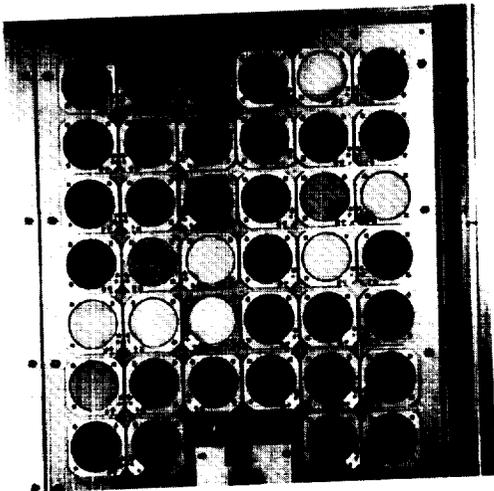
Figure 331
Photo No.: KSC-390C-2070.11
Dup. Neg. No.: L91-10235
LISAR No.: EL-1994-00479
Photo Credit: KSC
Photo Date: 3/19/90
Location: KSC SAEF II
Subject: Postflight Detail of Upper Right of Tray D6

Figure 331 (Postflight). This photograph is of the upper right one-sixth of the tray. The different colors of the detectors are due to reflections of surrounding areas. Some small impacts on the sensors are visible. There is some discoloration of the mounting hardware and the baseplate.

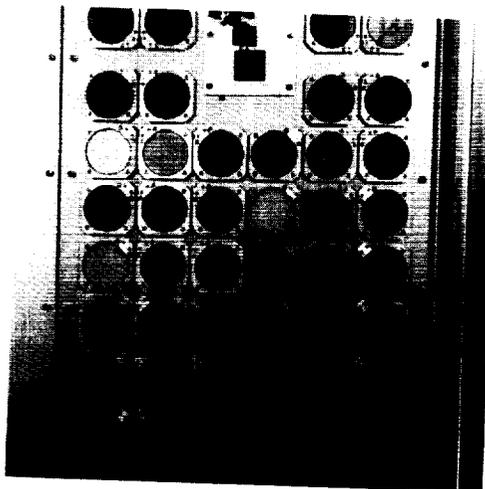
Figure 332
Photo No.: KSC-390C-2070.12
Dup. Neg. No.: L91-10236
LISAR No.: EL-1994-00480
Photo Credit: KSC
Photo Date: 3/19/90
Location: KSC SAEF II
Subject: Postflight Detail of Lower Right of
Tray D6

Figure 332 (Postflight). This photograph is of the lower right one-sixth of the tray. The different colors of the detectors are due to reflections of surrounding areas. Some small impacts on the sensors are visible. There is some discoloration of the mounting hardware and baseplate.

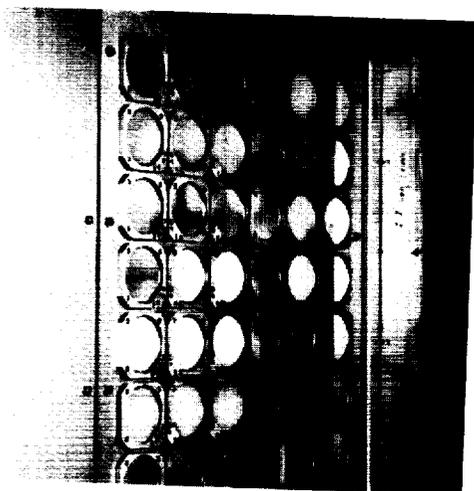
Figure 333
Photo No.: KSC-390C-2071.02
Dup. Neg. No.: L91-10238
LISAR No.: EL-1994-00481
Photo Credit: KSC
Photo Date: 3/19/90
Location: KSC SAEF II
Subject: Postflight Detail of Upper Right of Tray D6

Figure 333 (Postflight). This oblique view photograph is of the upper right one-sixth of the tray. The different colors of the detectors are due to reflections of the surrounding areas. Note the reflection of the tray restraining bar in the surface of the right row of detectors.

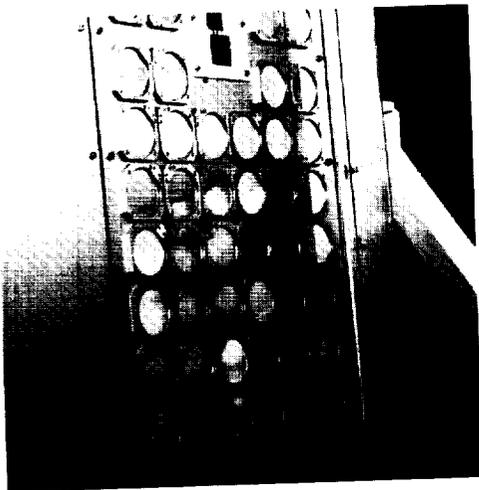
Figure 334
Photo No.: KSC-390C-2071.03
Dup. Neg. No.: L91-10239
LISAR No.: EL-1994-00482
Photo Credit: KSC
Photo Date: 3/19/90
Location: KSC SAEF II
Subject: Postflight Detail of Lower Right of
Tray D6

Figure 334 (Postflight). This oblique view photograph is of the lower right one-sixth of the tray. The different colors of the detectors are due to reflections of the surrounding areas. Note the reflection of the tray restraining bar in the surface of the right row of detectors.

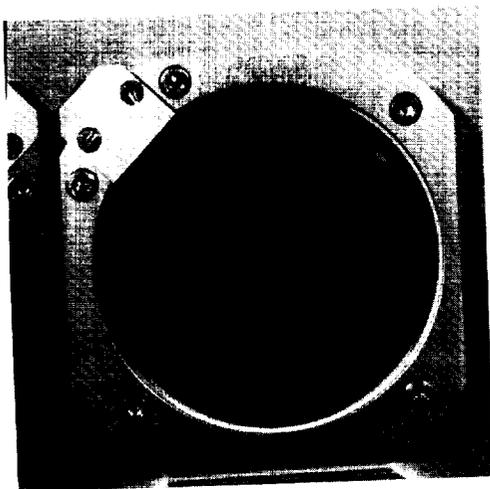
Figure 335
Photo No.: KSC-390C-2071.04
Dup. Neg. No.: L91-10240
LISAR No.: EL-1994-00483
Photo Credit: KSC
Photo Date: 3/19/90
Location: KSC SAEF II
Subject: Postflight Detail of Tray D6

Figure 335 (Postflight). This close-up photograph is of a sensor and shows an impact crater. The sensor is located at the lower left corner of the solar cell baseplate. Other areas on the sensor also indicate impacts.

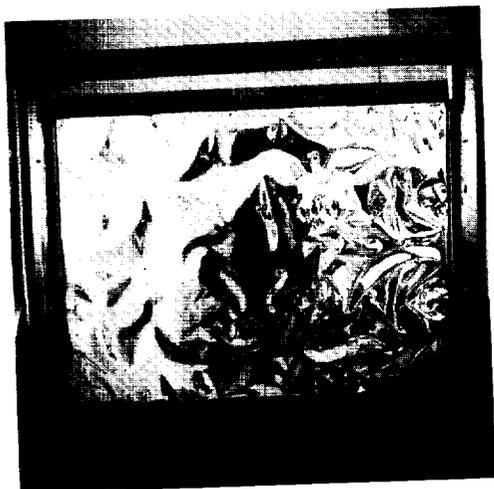
Figure 337
Photo No.: KSC-390C-1472.02
Dup. Neg.: L91-10248
LISAR No.: EL-1994-00207
Photo Credit: KSC
Photo Date: 2/26/90
Location: KSC SAEF II
Subject: Postflight Survey of Tray D7

Figure 337 (Postflight). The surface of the thermal cover appears specular with green and white discolorations from photographic lights and reflections of the surrounding area. The black or brown dots are impacts or penetrations. The cover is not as taut as in the in-flight photograph and locations of the Velcro attachment pads are not as prominent. The ground strap has no apparent physical damage, but it is a darker copper color than in the prelaunch photograph.

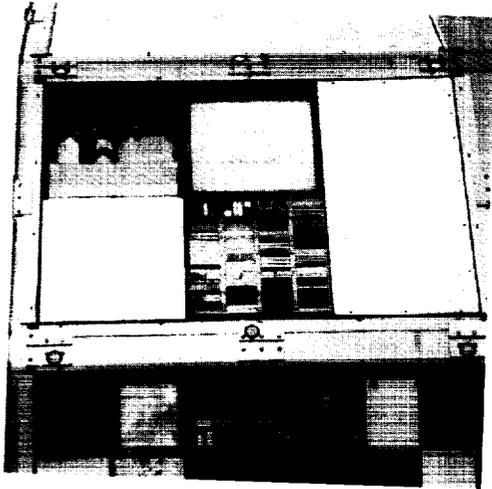
Figure 345
Photo No.: S32-76-013
Dup. Neg. No.: L90-10377
LISAR No.: EL-1994-00662
Photo Credit: JSC
Photo Date: 1/12/90
Location: In Flight
Subject: In-Flight Survey of Tray D8

Figure 345 (In Flight). The experiment hardware appears intact. The EPDS cover located in the right one-third of the tray has no apparent change in color, but the SCU cover located in the upper center one-sixth of the tray has a brownish tint with a darker tan strip along the lower line of screws. Colors of the composite material samples are bright and clear. Some material samples appear to be blue in this photograph, but they are not in prelaunch or post-flight photographs.
